Meeting **Victor Harbor Horse Tram Authority**
Date **8 April 2020**
From **Meg Whibley**
Subject **General Manager Operations Report**
Report Number **6.1**

Response to request for reallocation of capital budget for tram track replacement works on Granite Island

TRACK CONDITION ASSESSMENT

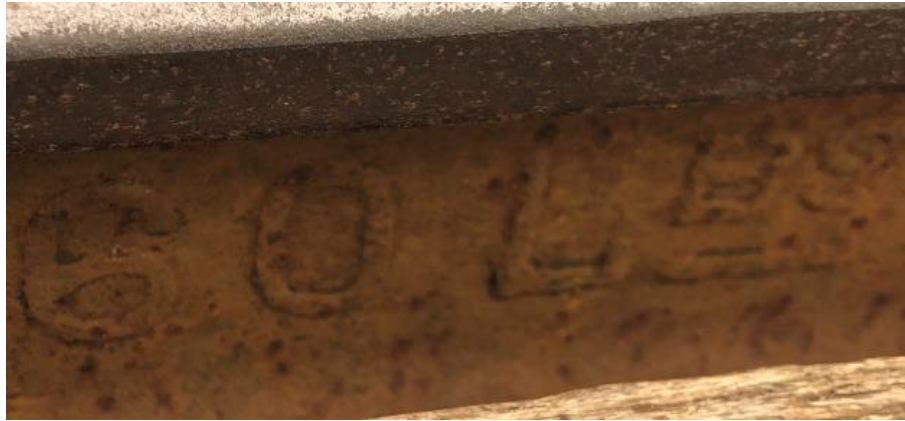
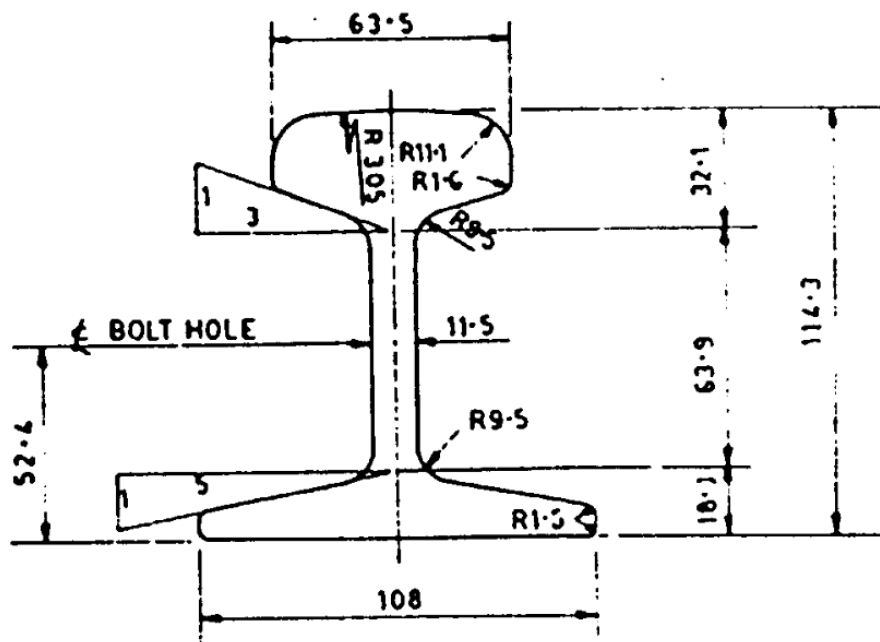
Figure 3.1: 60lb AS Rail Profile

Rail installed in this section comprises 60lb/yd AS rail as identified by markings on the rail web. Figure 3.1 below includes the as rolled profile of the rail.

60lb AS
ACTUAL WEIGHT 29.87 kg/m

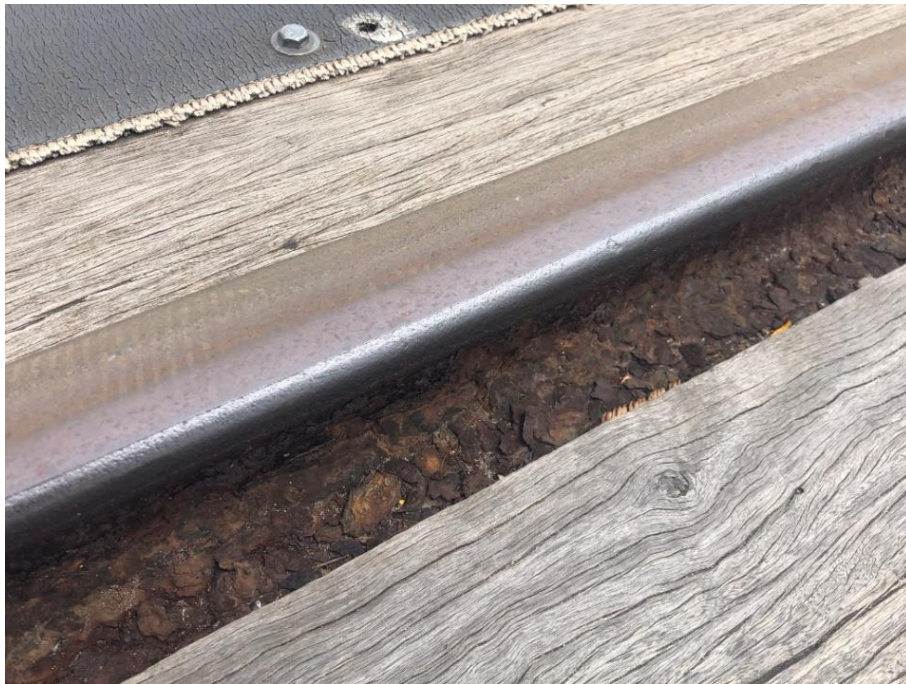
Figure 3.2: Corroded Rail Foot and Web

Corrosion of the rail foot and web is evident, with material flaking from the rail. The quantity of corrosion is the result of drift sand from the adjacent beach blowing in and holding moisture. The sand also contains salt which results in accelerated corrosion. Figure 3.2 illustrates typical rail corrosion in this track section.

Despite the corrosion, the rail is currently performing satisfactorily, and the rail web remains solid. From feeling the rail, a significant portion of the 11.5mm as manufactured web appears to remain. Measurements would need to be undertaken to determine exactly the width of the web remains. Rail exists in other networks with far more web corrosion present, and with greater operating axle loads than this tramway, which has continued to perform satisfactorily in low speed rail environments. Derailment is unlikely to result from a rail web failure where the web would buckle under load and the rail head subside. If the web was to fail in such a manner is likely that an impact would be experienced in the ride quality only.

The rail in this section is considered fit for purpose. Monitoring of the rail should be performed, in conjunction with routine removal of the sand to minimise the rate of future corrosion, to ensure the rail continues to be fit for purpose for a further 18 months.

1. VHHTA should continue to monitor the rail in the track section outside the tram office, in conjunction with routine removal of the sand to minimise the rate of future corrosion, to ensure the rail continues to be fit for purpose for a further 18 months.

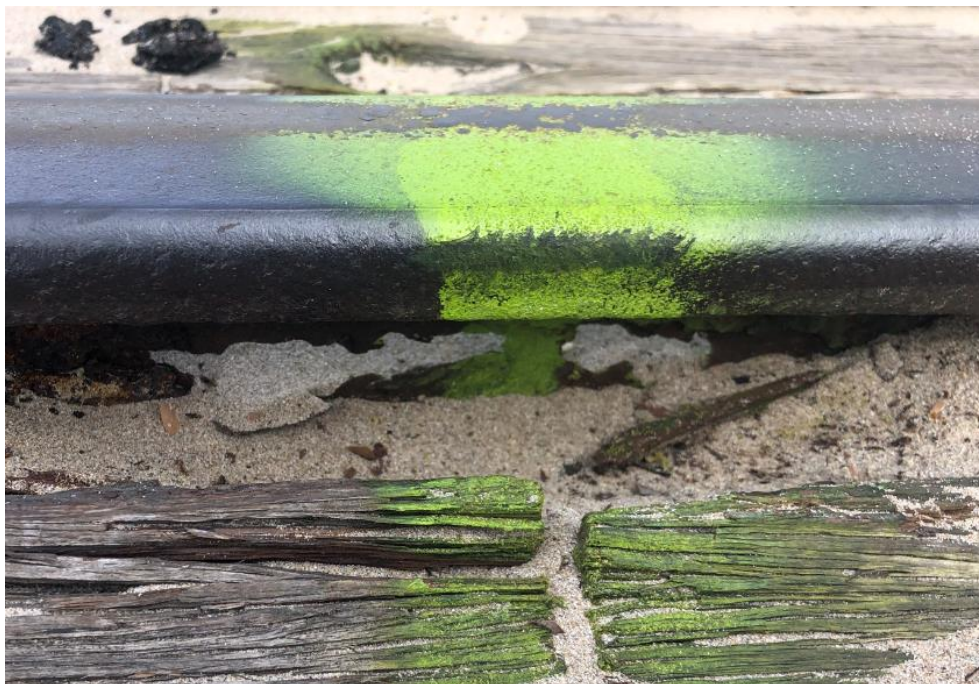
Figure 3.3: Isolated Web Penetration due to Corrosion

On 14 March 2020, VHHTA volunteer Kim Bayly identified a location in the rail on the Victor Harbor end of the causeway where corrosion had resulted in a penetration of the web. Figure 3.3 illustrates the web penetration in this track section.

The rail in this section currently remains fit for purpose, as the load from the tram wheel has a functioning load path with the rail head spanning the web penetration, though this section of rail should be subject to prompt repair to reduce risk of failure. Repair could include installation of fishplates at the

isolated location or replacement of the section of rail in this area. The latter repair has the greatest risk reduction.

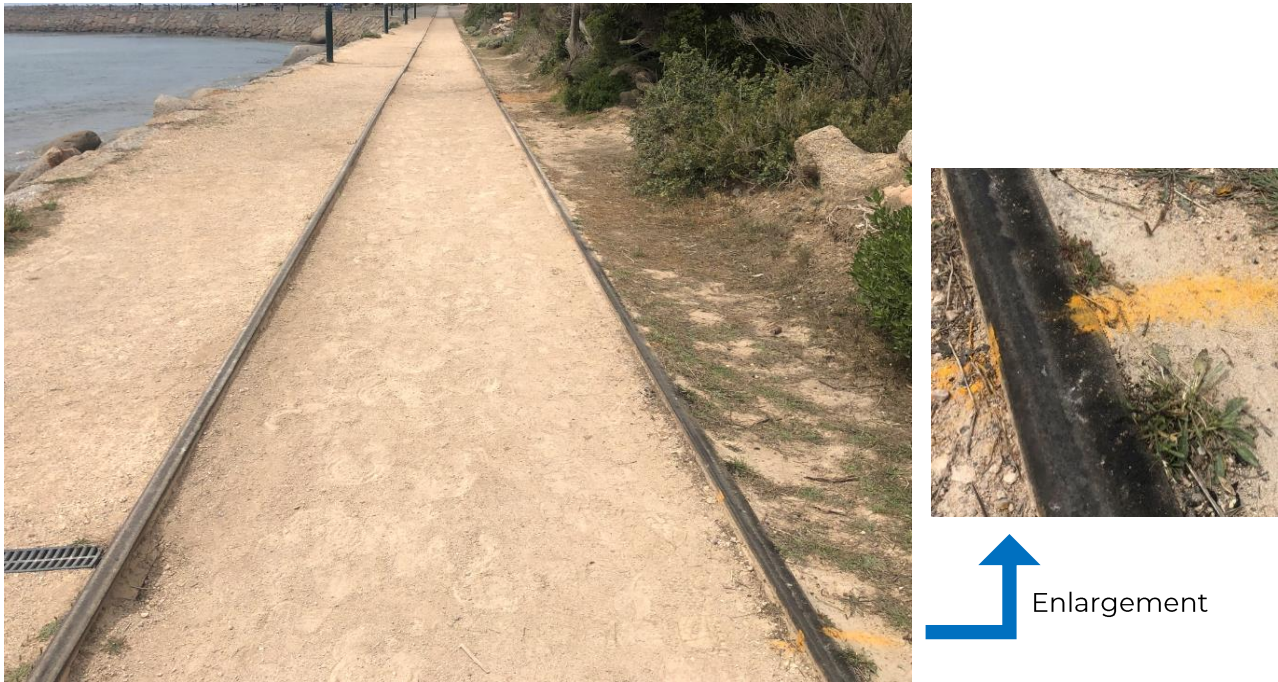
Figure 3.4: Typical Track on Granite Island with Marked Gauge Measurement Location

There were no noticeable track geometry faults of concern.

As an improvement, it is suggested that the VHHTA adopt a regular frequency for monitoring, potentially monthly, to improve regularity of measuring and provide further confidence in the state of the track gauge. This frequency could be reduced in dry seasons if consistent measurements are recorded indicating stable gauge.

2. VHHTA should continue to monitor gauge and install gauge bars as a method of temporary repair where wide gauge exceeds 20mm. As an improvement, it is suggested that the VHHTA adopt a regular frequency for monitoring, potentially monthly, to improve regularity of measuring and provide further confidence in the state of the track gauge. This frequency could be reduced in dry seasons if consistent measurements are recorded indicating stable gauge.

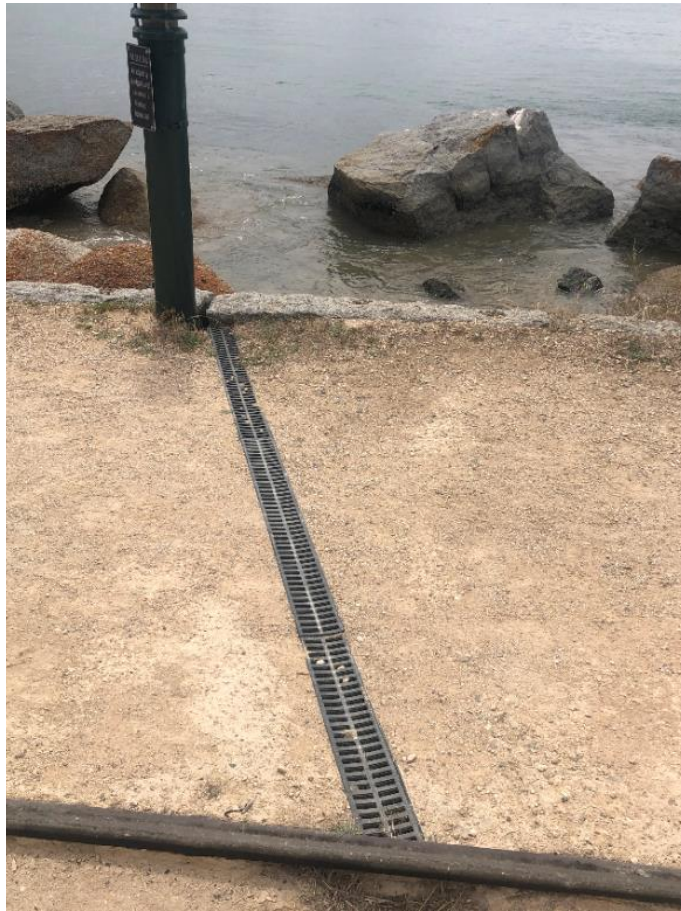
Figure 3.5: Typical Grated Drain

Open and grated drains have been installed to remove some water from the area between the rails and adjacent to the track to improve conditions for the horses and reduce water ingress into the track structure. Figure 3.5 shows a typical grated drain which has been installed to remove surface water from between the rails and adjacent to the track.

The drainage is considered fit for purpose.

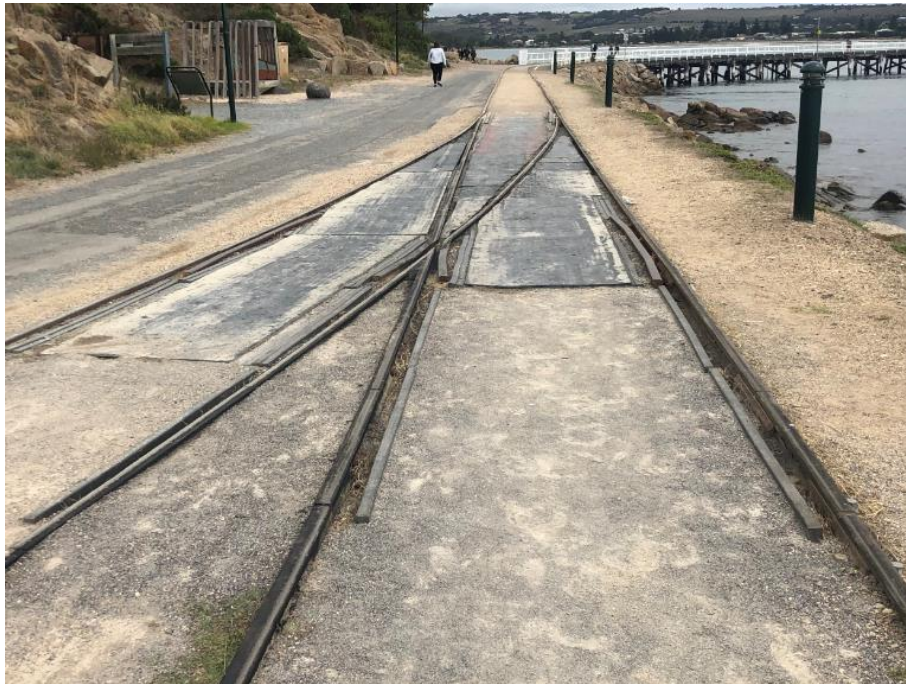
Figure 3.6: Typical Fixed Blade Turnout

The v blade and v crossing areas showed signs of wear and repair (weld build up and grinding) that has been completed during their life. There were no notable defects to report. Figure 3.6 shows the turnout installed at the causeway end of the dual section of track.

The turnouts are considered fit for purpose.
